FW: SICK VPS Follow up

SICK Vehicle Profiling System Results Report

After Final Alignment & Calibration
(6th June 2016)

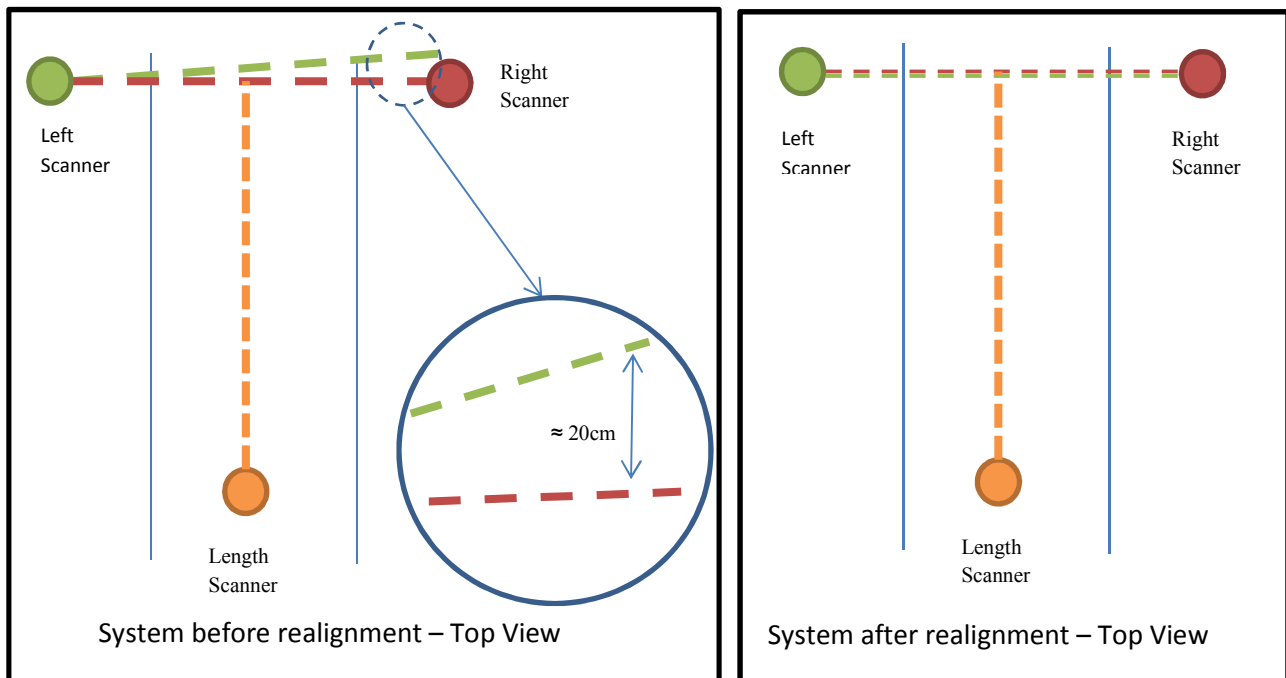
After the system was initially installed testing showed a systematic error of approximately 15 to 20cm in the length measurement. Both width and height measurement were found to be accurate.

It was determined by SICK that the cause of the length inaccuracy was due to the misalignment of one of the installed scanners. This document outlines the results found after the re-alignment and re-calibration of the system.

Realignment of left scanner was carried out (as shown below) and full recalibration was carried out. Seventeen vehicles were then run through the system and VPS measurements were compared to manual measurements taken by checking station operators.

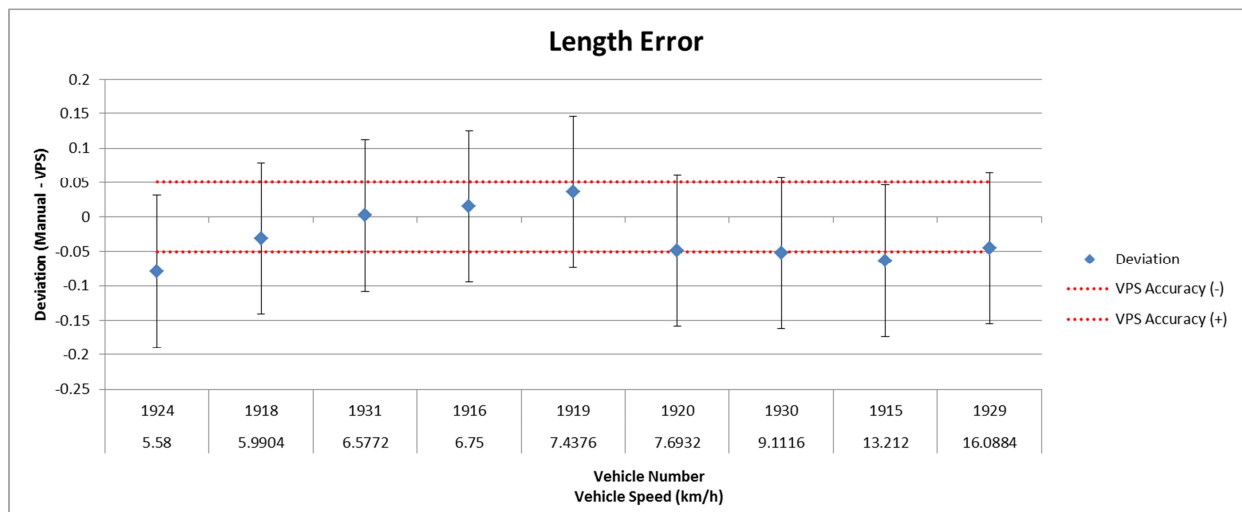
Chart 4.1.1

Length: Realignment of the VPS System has improved the length measurement accuracy within the specification. Prior to realignment the average error was approximately -18cm over 32 valid vehicle measurements. After realignment the average error was approximately -3cm over 9 valid vehicle measurements.

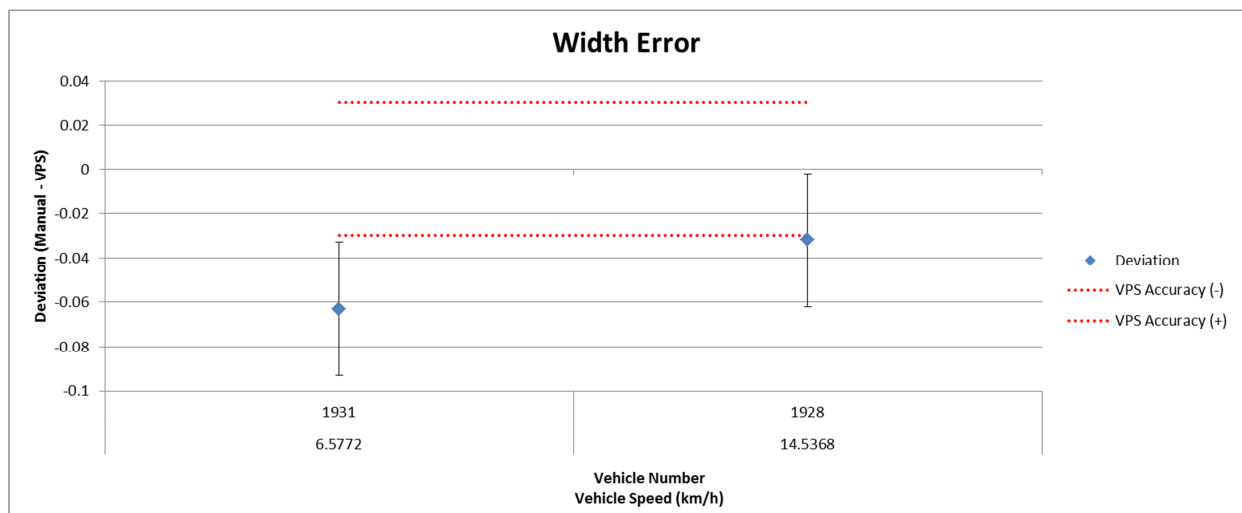
Chart 4.2.1

Width: Testing the width measurement for accuracy proved to be quite difficult. This is due to the fact that the operators generally only measure the widest point on the vehicles trailer while the VPS will measure the widest points on the entire vehicle. The widest point measured by the VPS is most commonly vehicle mirrors or straps / chains used to restrain the load.

Operators will need to use the graphical user interface to determine if the width measurement of the VPS is valid or can be disregarded.

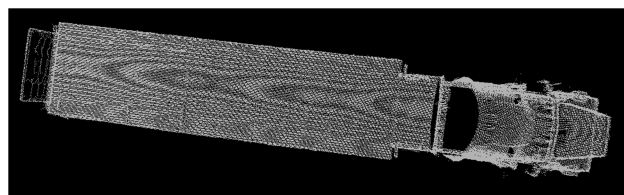
Image 4.2.2 (Vehicle 1931)

Height: The results of the height measurement we consistently accurate. The only issue encountered was the VPS detecting the vehicles antenna. In this case the operator would need to use the graphical user interface to determine if the height measurement is relevant.
