Cooled vs non-cooled Thermal Imaging Sensors

Houston Radar Length Detection System

Improved Mass Screening: Weight-In-Motion and TIRTL integration

TIRTL & LTI dimension scanner integration

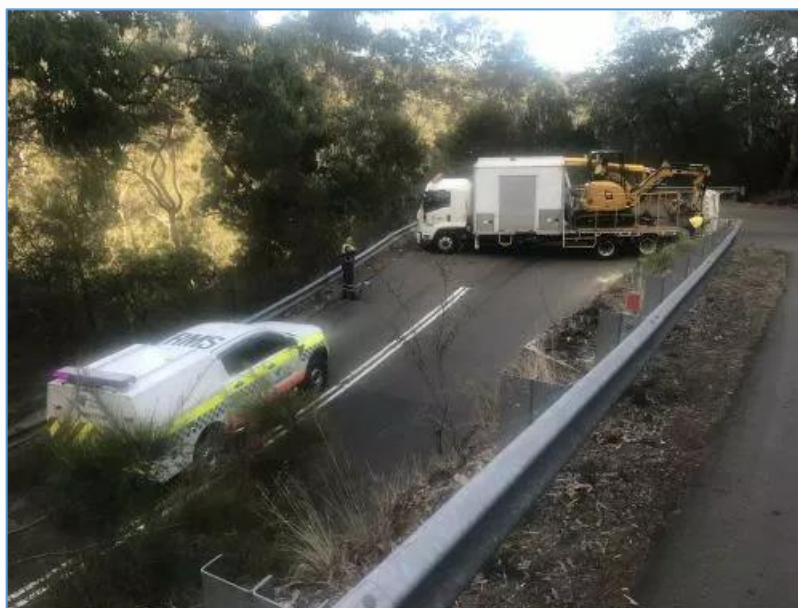
Galston Gorge has seen countless heavy vehicles become trapped over the past decade, with almost 100 over-length trucks becoming stuck in the past year alone.

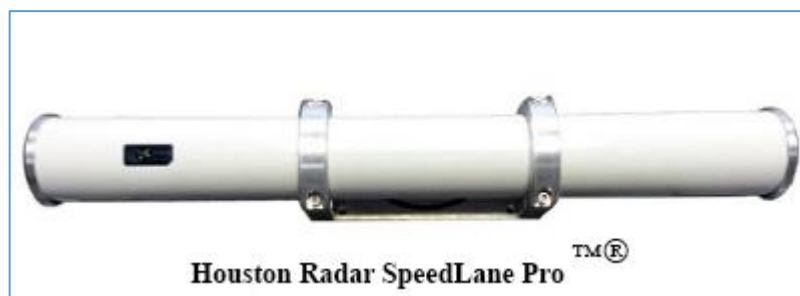
Houston Radar SpeedLanePro is a dual beam, low power side-fire radar. It is designed to accurately detect lane, speed and class of individual vehicles and compute per lane volume, occupancy, gap and average speed.

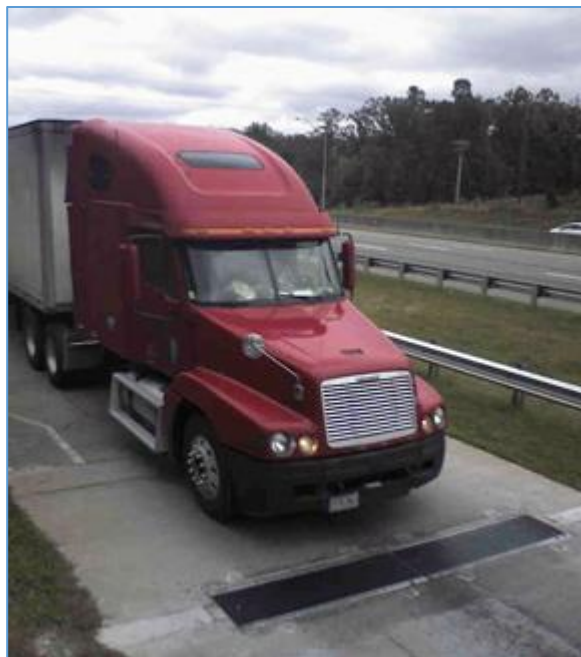
The PAT Bending Plate from IRD is used for Weigh-in-Motion (WIM) solutions in heavy vehicle safety stations in NSW. The importance of measuring the loads of driving road vehicles has increased enormously. Traffic safety, the protection of road infrastructure and statistical data are the main purpose of Weigh-in-Motion equipment. These WIM's are rated up to a weight accuracy of 10%+- of the axle weight up to 200km/h.

Although the WIM itself is a globally world leading solution for weight vehicles, its solution for measuring axle spacing is poor. Electromagnetic loops installed in the roadway do not meet the requirements for a screening lane which requires at least 95% of vehicles to be weighed correctly. Loops regularly miss-trigger or double trigger on vehicle axles resulting in the WIM miss-classifying the vehicle and applying an incorrect maximum weight tolerance. For this reason, RMS has integrated the world leading axle classification tool, the TIRTL into the WIM to improve classification and vehicle weighing accuracy.

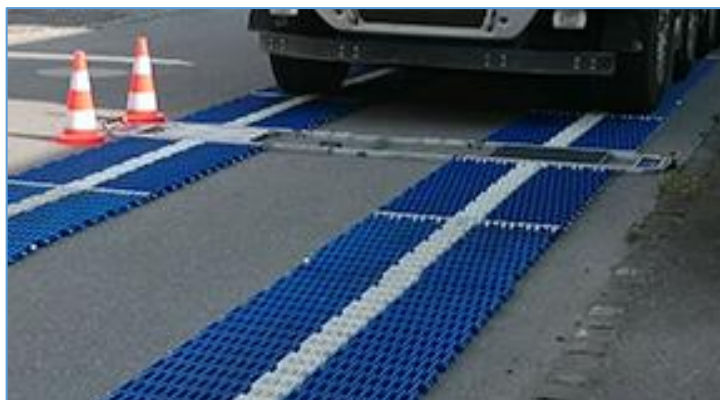
The 10C III solution enables dynamic weighing using a flex frame / lead-up mat which the heavy vehicle is required to drive on before and after being weighed on the scale itself.

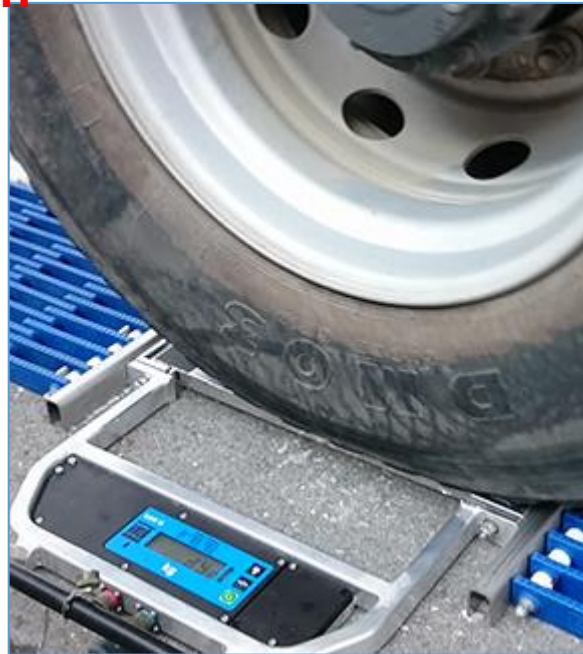
10C III Specifications and uses

- Dynamic measurement for overload indication
- Dual-scale system configuration with computer-based processing for reporting, protocol printing and data archiving

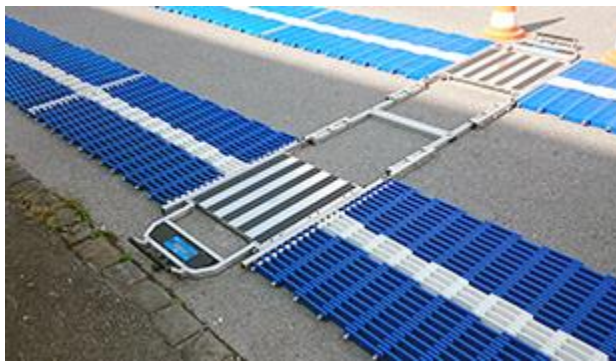
Hardware: During pre-trial review, RMS have come to the conclusion that due to the very large size and weight of the flex frames / lead-up mats pictured below, that in fact there is no current way that they can be transported in the current RMS vehicles. The flex frames themselves would require a secondary trailer to be towed by each vehicle which RMS have advised is unrealistic.

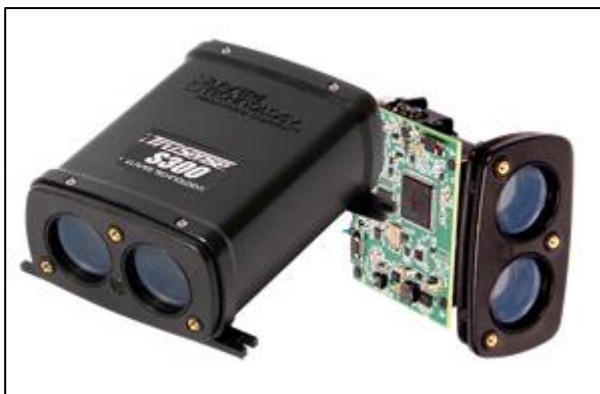
The LTI laser scanner was primarily designed as an overhead vehicle detection solution. ie/ placed on bridges and overpasses etc, it can supposedly accurately detect the height of a vehicle passing.

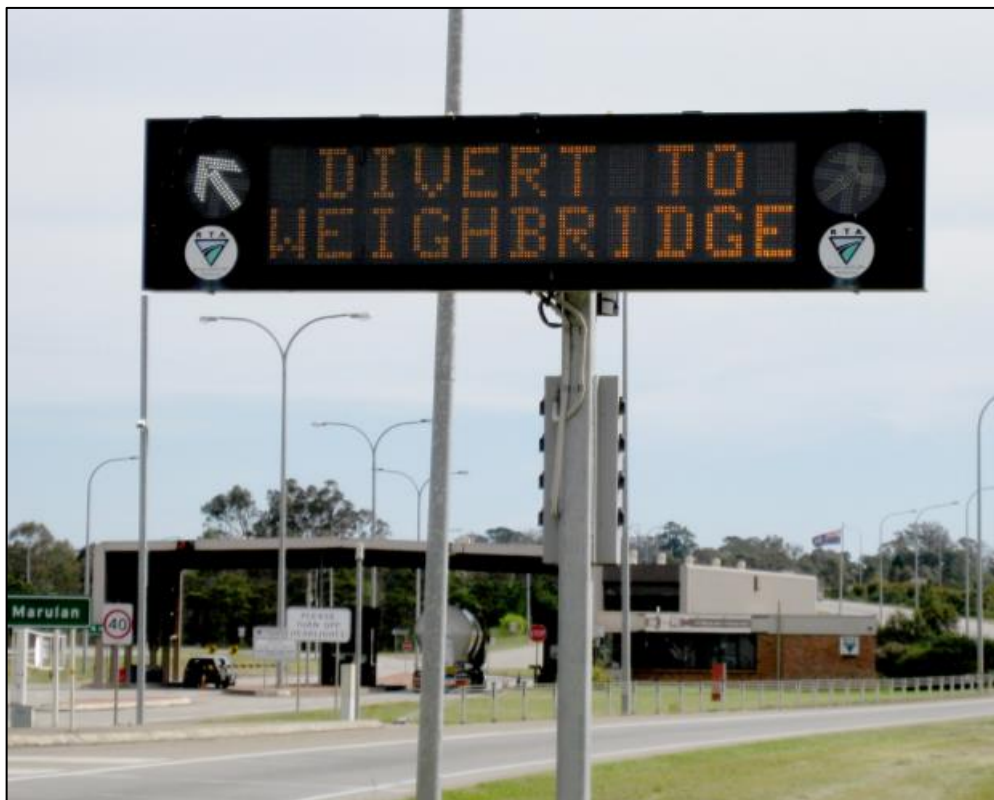
For this trial, RMS installed the camera at Marulan HVSS. The LTI laser was installed on a gantry. The TIRTLS were available at ground level in the HVSS screening lane where heavy vehicles are required to enter for screening.

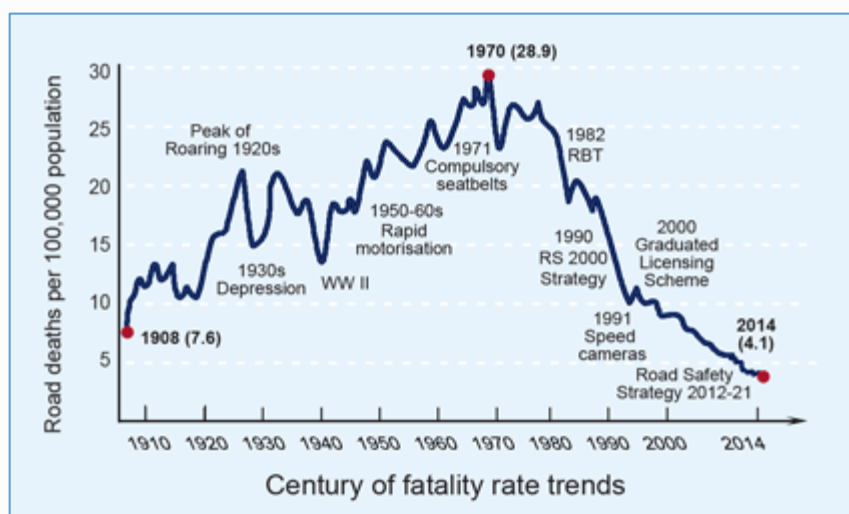
The Centre for road safety in Transport for New South Wales has documented that since the 1970's, fatal crashes have drastically reduced, until a spike in 2014 and following years.

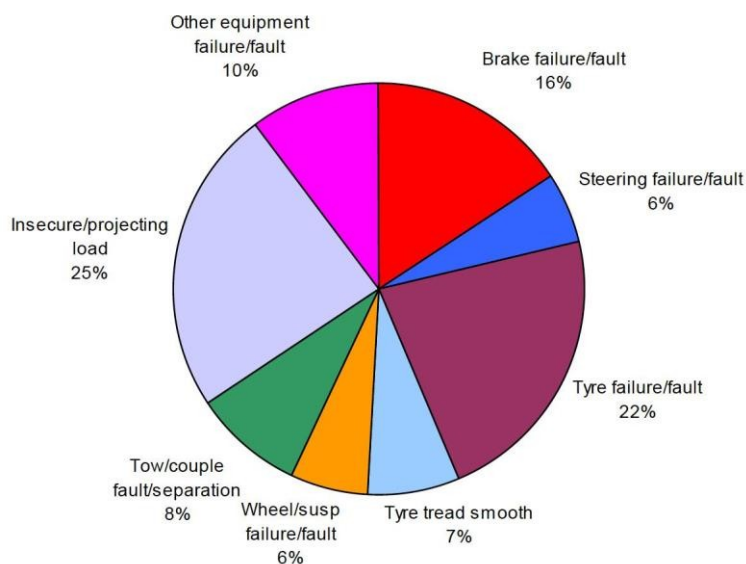
Heavy Trucks in Single Vehicle Crashes with Equipment Factor, 2010 to 2012, Type of Vehicle Equipment Factor

Statistics published January 2014 show that one in seven (15%) single heavy vehicle crashes had an equipment failure reported for that truck. Of these faults, brake failure made up 16%, tyre failure made up 22% and wheel/suspension failure made up 6% of documented incidents. Thermal imaging has the potential to detect these types of faults, which equate to 44% of total equipment related failures.
